Chandler Canal Fish Screen Low Water Evaluations 2001

**The U.S. Bureau of Reclamation
Yakima Project Office
Yakima, Washington**

**Battelle Pacific Northwest Division
Richland, Washington**

March 2002

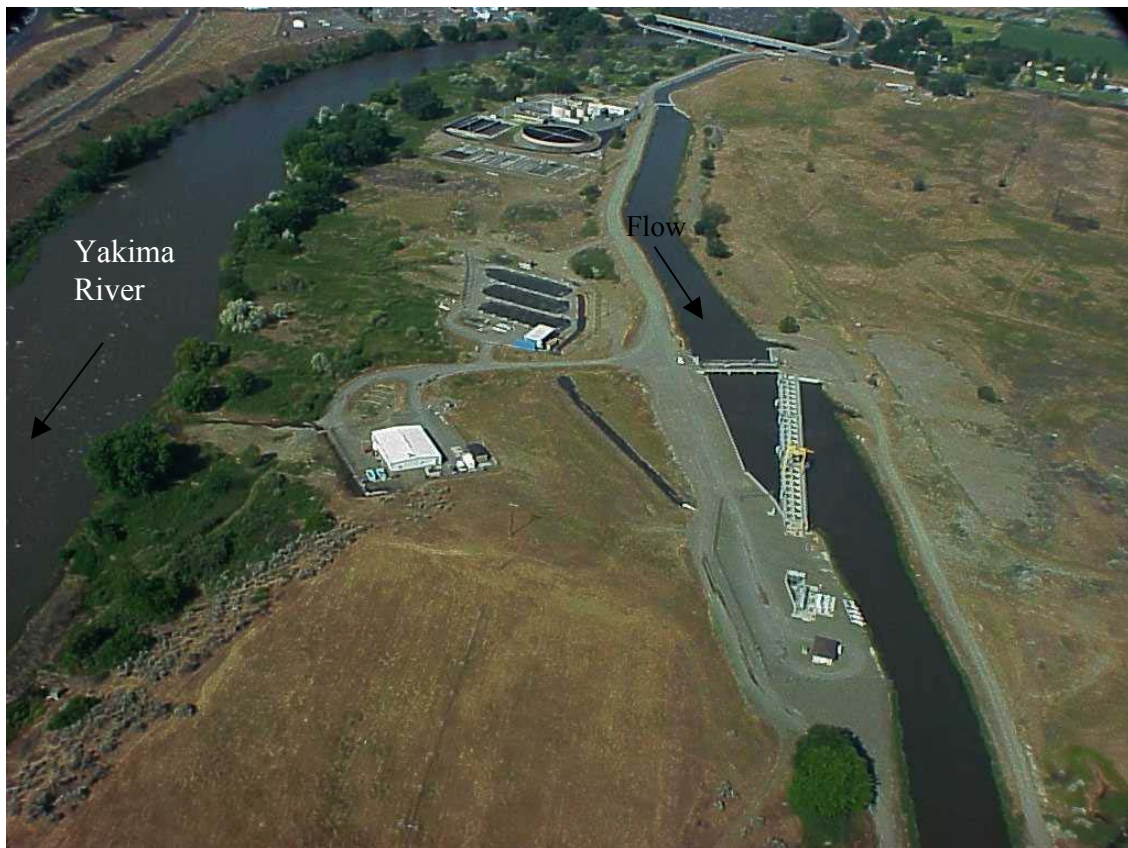
Figure 2. Chandler Canal Fish Screen Facility (right center) near the Yakima River (left). The Juvenile Evaluation Facility (JEF) is the white building in the left center of the photograph. Photo courtesy of Dave Fast, Yakama Nation.

Chandler Canal is located on the left bank of the Yakima River near Prosser, Washington. The head gates of the Chandler Canal withdraw water from the Yakima River at the Prosser Diversion Dam at river mile 47.0 (Figure 2). The facility consists of 24 rotary drum screens (13.5 feet diameter, 12 feet long) and a fish bypass system composed of three fish bypasses (two intermediate and a terminal), a separation chamber with four bypass water recovery pumps located behind vertical traveling screens, and a fish return pipe. The water is removed from the bypass through the vertical traveling screens, passed over wooden weir structures and then into an underground pipe that returns to the bypass outfall in the Yakima River. The forebay elevation is about 631 feet (~75% submergence) at the maximum canal flow of 1500 cfs. The juvenile fish screen structure (Figure 3) is located on the canal approximately 1 mile downstream of Prosser Dam. The Chandler Canal conveys Yakima River water and all life stages of anadromous fish found in the Yakima (USDI 1986). The fish screen facility was designed to intercept the fish in the canal, concentrate them into a smaller volume of water, and then return the fish (and the smaller volume of water) back to the Yakima River. It should also be noted that

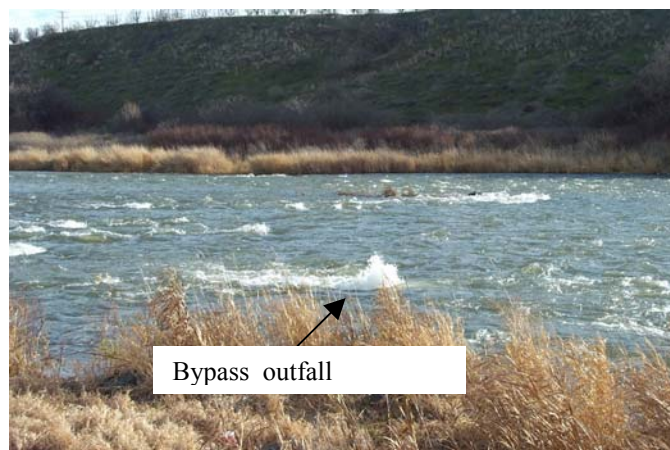
Figure 40. Chandler Canal Fish Screen bypass outfall in the Yakima River. Surging is evident in the center of the photo.
